# The test Result Analysis of the Basic Bricks

## --RHI, MH-90, MH-90-1/2/3

We have developed 3 kind of Magnesite-hercynite bricks (MH-90-1, MH-90-2 and MH-90-3) based upon our available brick MH-90 for burning zone of cement rotary kiln. We take a sample brick from RHI in China for comparison evaluation. The test results and relevant analysis are as follows:

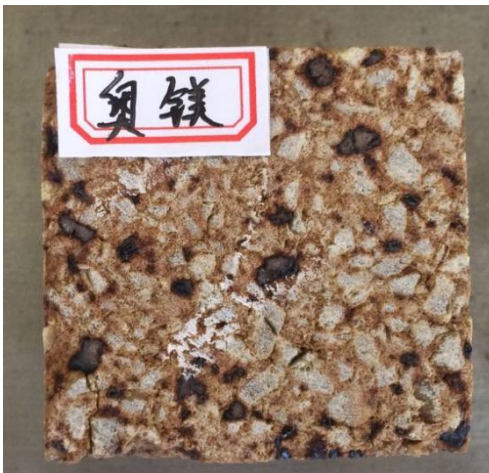
RHI after first time process

**Note: Slight Crack is found on MH-90, MH-90-1 & MH-90-3 while no crack on MH-90-2 and RHI.**

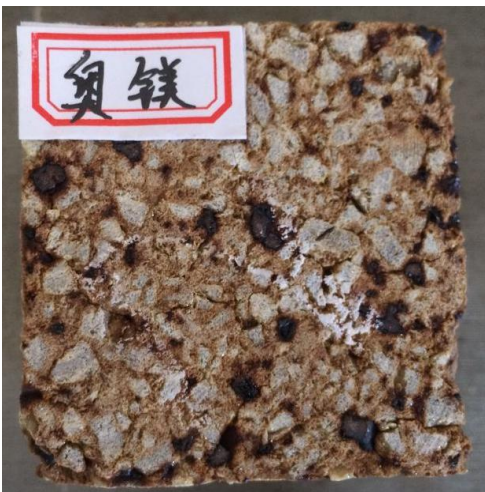
**RHI after 3-time process**

**Note:** After 3 time process, there is visible crack on RHI and MH-90-2, and the cracks of another 3 become more obvious. Also some spalling is found on MH-90-1 and MH-90-3.

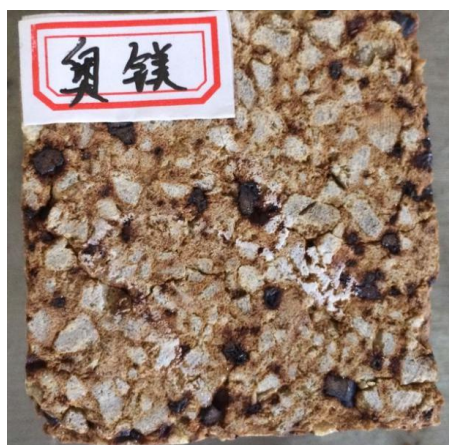
**RHI after 5-time process**

Note: The crack of all sample modules become more obvious than before.

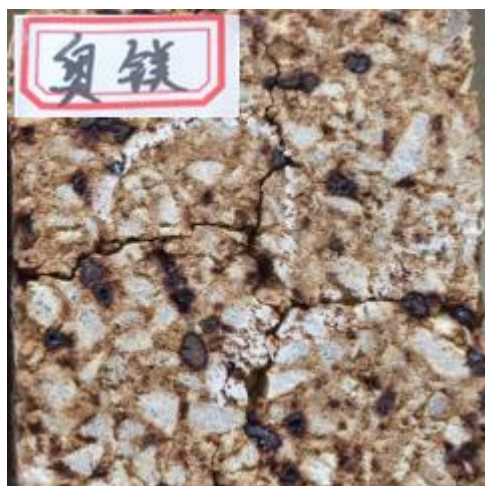
RHI after 20-time process

**Note:**The obvious crack is found on all sample modules after 20-time process.

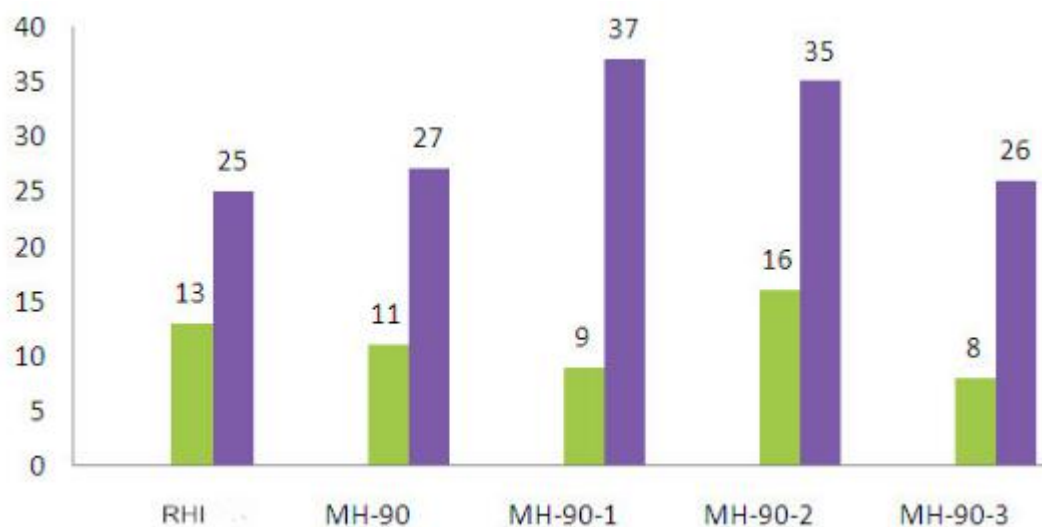
Reduction Rate of Strength after Process 5 times (%)
2.

Reduction Rate of Strength after Process 20 times (%)

#### B.Strength Reduction

**after 5 time process:**MH-90,MH-90-1 & MH-90-3 are superior.

**after 20 time process:**MH-90,RHI & MH-90-3 are superior.
